CLAIMED PUBLIC FOOTPATH

from MARTHOLME LANE, GREAT HARWOOD, HYNDBURN BOROUGH
to PUBLIC FOOTPATH No. 11, READ PARISH, RIBBLE VALLEY
BOROUGH.

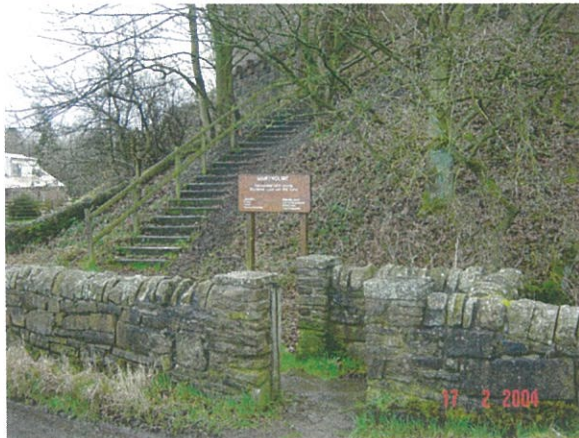
Access to this claimed route is either from the disused railway from the south, or from the west where there are a series of flights of steps. These are entered from Martholme Lane through a square opening in the wall with a stone paved surface, then over a worn path in the grass banking, past a Lancashire County Council notice board before going up the timber and stone steps with timber posts and double half round timber handrails.

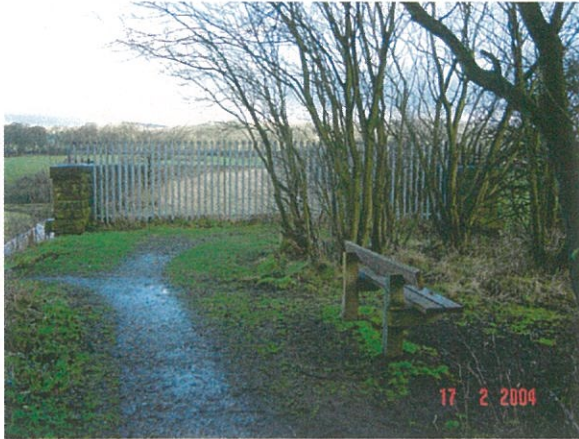
At the top of the steps there is a stone surfaced path on the disused railway line and a timber seat placed to the east of this path and facing to the east and overlooking the valley of the River Calder.

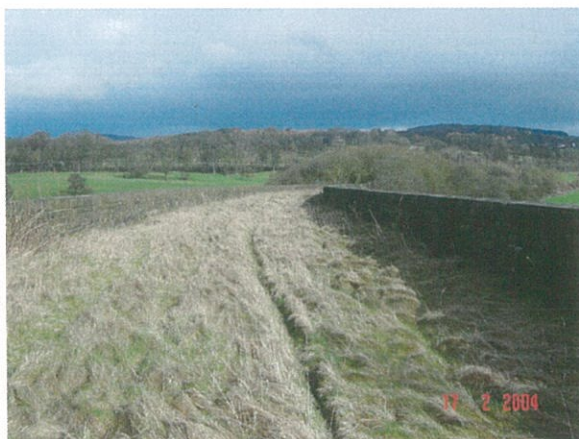
Over the viaduct there is a "main" pathway visible roughly along the centre of the bridge as well as several meandering paths to the sides of this. The width available is approximately 8 metres between the parapet walls.

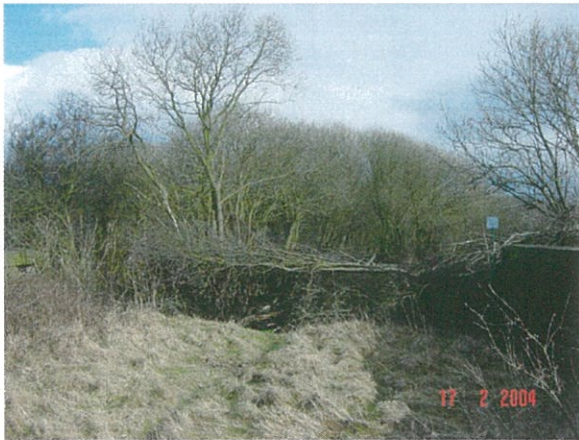
At the far end of the structure, at point **B**, there is a barricade of trees and bushes which have been placed across the end of the structure, these appear

to have been placed in an area of land which has been excavated to a depth of approximately 1 metre.

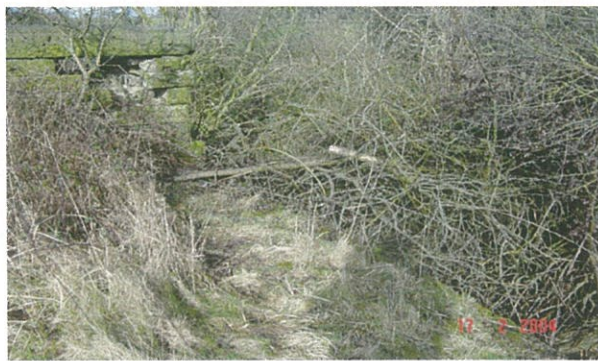
Although this barrier is intended to stop public use, it is possible to climb over the trees and it appears that there are three points where people have crossed this feature. (Two on the westerly side and one on the east) A photograph of the end of the parapet wall shows where the growth of brambles etc. leaves an access to one of these crossing points.

The end of the stone parapet wall on the westerly side shows signs of damage underneath the coping stones, this would appear to be caused by the machinery which excavated the trench or placed the trees. The rest of the structure would seem to be in a very good condition, with the walls in good order and only a small amount of shrub growth from the surface and no plants in the stonework.

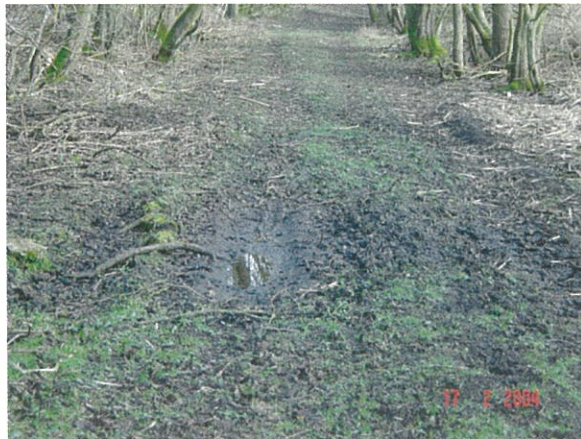
The claimed route continues to follow the disused railway line with trees to both sides and a clear, wide path. The surface is firm and even with little surface growth with a pair of faint tracks visible. There was one area where a muddy depression existed and it was possible to see footprints as well as animal tracks to the side of the puddle in the centre of the track.

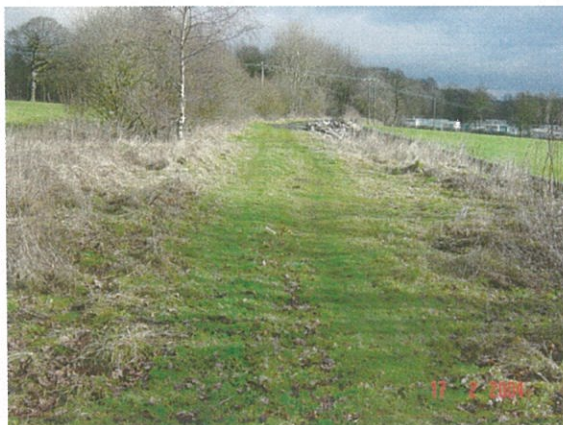
After a distance of approximately 300 metres the wooded sides disappear and there is a wide, open grassed area with a track approximately 4 metres wide in the centre, with wide areas to both sides with bramble and nettle growth.

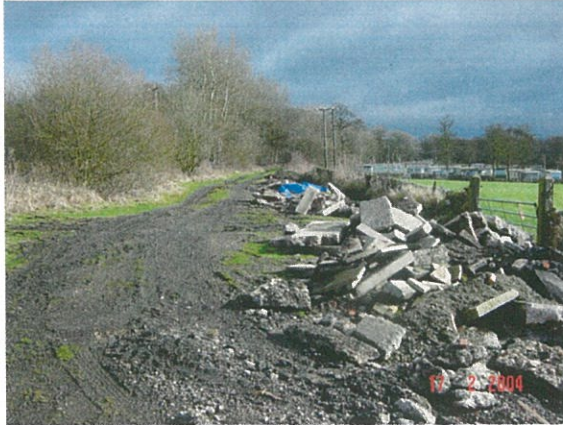
After approximately 80 metres the an area of land between the former track bed and the field boundary wall on the southerly side, has been excavated,

and a metal pipe had been exposed in the ground, this appears to be the same pipe that was exposed at the viaduct and turned out over the slope. Point B.

On this excavated area there has been tipped pieces of concrete etc. on the southern side of a very well used vehicular track.

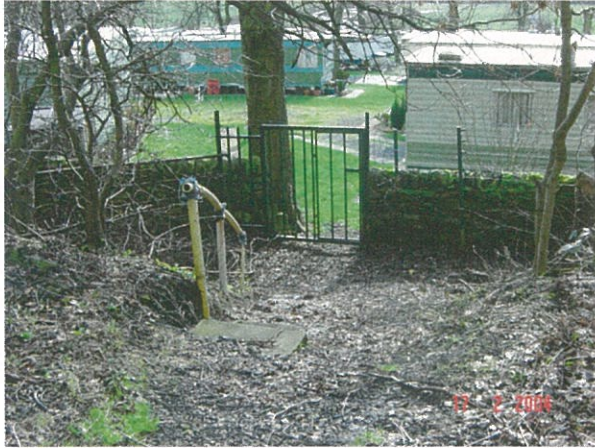
There is a flight of steps down the slope of the bank on the southern side with a handrail made from scaffolding, this leads to a gap in the stone wall where there is a green painted metal panel placed across the opening. This has a gateway included in it. There are spikes to the side of the panel and barbed wire to the top and to both sides. To the easterly side of this panel there is an old metal field gate placed across the level area to the side of the stone wall. This is a well-used private access from the caravan site, which is in the same ownership as this part of the former railway land.

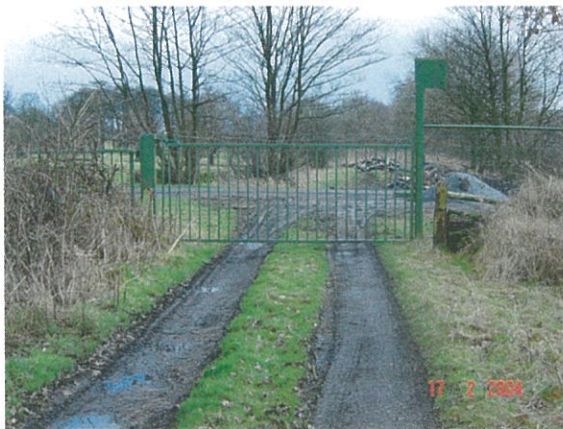
The claimed route continues to follow the well used access track. After approximately 180 metres there is a large, locked, green metal gate with a similar length of fence running from this to the north to the boundary of the former railway land and the woodland. This also has barbed wire on top of this. To the south of the gate there are two metal mesh security fence panels. The southern most of these was leaning against one of the trees.

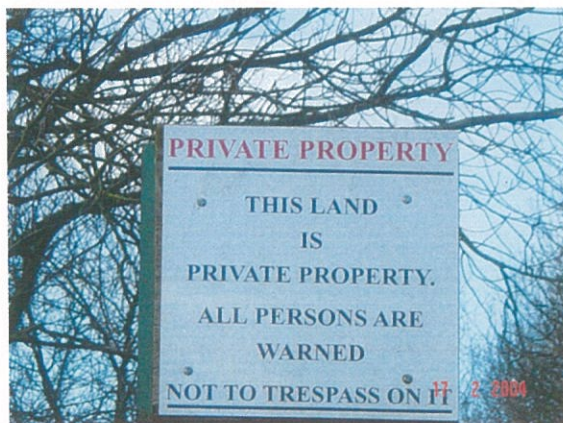
Fastened to the extended post on the southern side there is a notice with the same format and wording to that referred to above at point **B**.

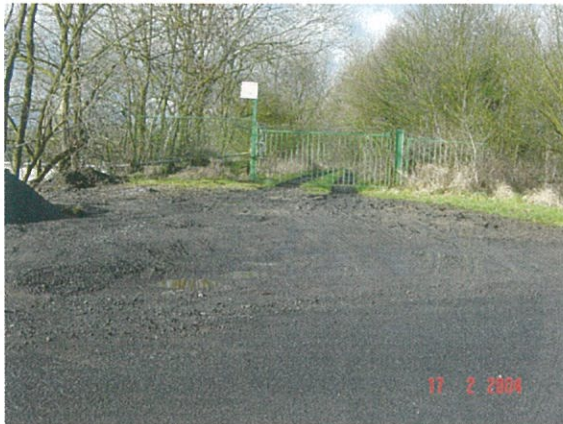
The claimed route passes through the gateway and over a wide, open area used extensively by vehicles for parking, turning and for material storage. This extends to join public footpath number 11, Read Parish that is

over a macadam surfaced occupation road leading to the Caravan Park and farm beyond at point C.

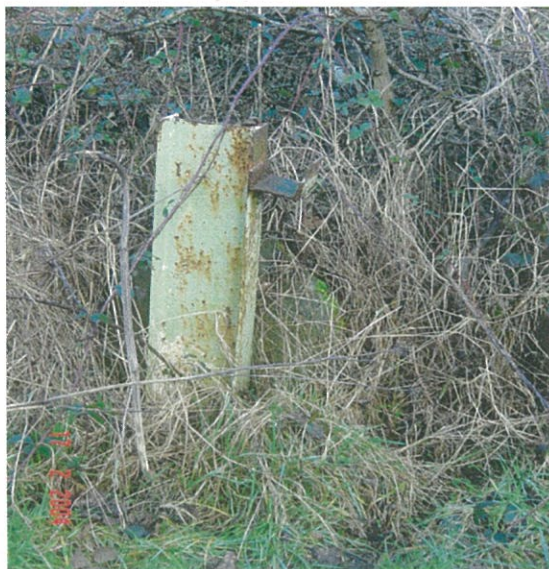
At a point approximately 1 metre to the west of the above gate, there are two metal stanchions set in the ground, the one on the north side has a bracket fixed to it.

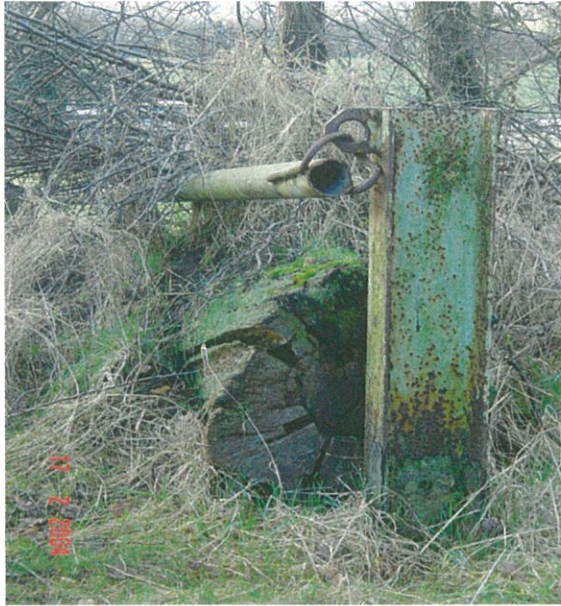
That on the south has a loop fastened to it, through which a metal tube is linked by a loop onto the post. It appears that this would have been a barrier, closing across the track onto the bracket on the other post. This appears to have been an access control, prior to the erection of the gate.

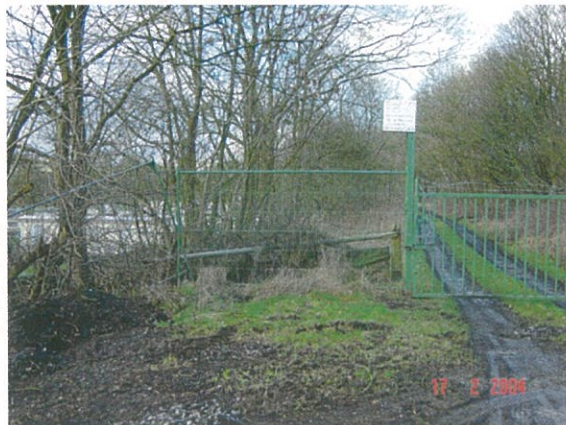
Whilst the metal gate and the attached fences does form a barrier to the claimed route it is possible to pass the end of the mesh panel where it ends short of the stone wall which is the caravan site boundary.

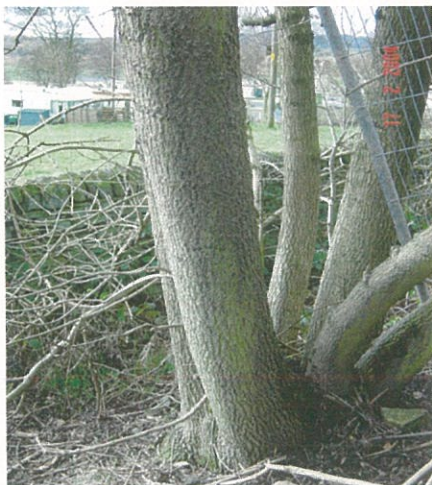
This involves passing around or through a multi trunk tree at the bottom of the slope down from the former track bed.

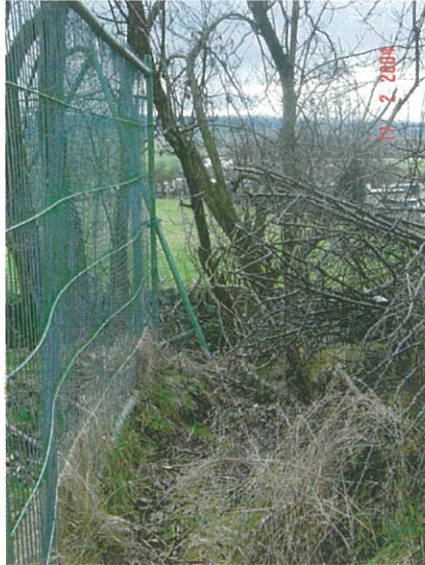
Beyond the tree and the mesh panel there is a visible area of trodden growth up the slope between the fence panels, and the former metal tube barrier, referred to above. This is approximately 1 metre wide and shows signs of use.

Whilst the use of the claimed route is obviously discouraged, there was evidence that this point had been used to gain access onto the claimed route, with a worn path clearly visible.
