CLAIMED PUBLIC FOOTPATH

from MARTHOLME LANE, GREAT HARWOOD, HYNDBURN BOROUGH
to PUBLIC FOOTPATH No. 11, READ PARISH, RIBBLE VALLEY
BOROUGH.

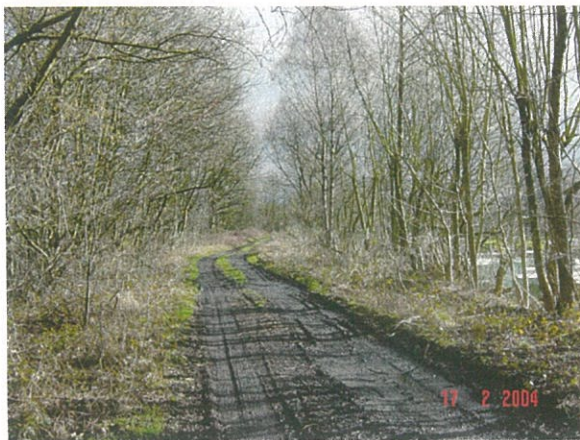
From this point there is a very well used track running towards a caravan park. After approximately 30 metres there are trees growing up both sides of the well used track and there

There is a flight of steps down the slope of the bank on the southern side with a handrail made from scaffolding, this leads to a gap in the stone wall where there is a green painted metal panel placed across the opening. This has a gateway included in it. There are spikes to the side of the panel and barbed wire to the top and to both sides. To the easterly side of this panel there is an old metal field gate placed across the level area to the side of the stone wall. This is a well-used private access from the caravan site, which is in the same ownership as this part of the former railway land.
